**REGIONAL DISTRICT OF
CENTRAL OKANAGAN**

Fintry Water Utility System Study Report

April 20, 2010

Project #10049

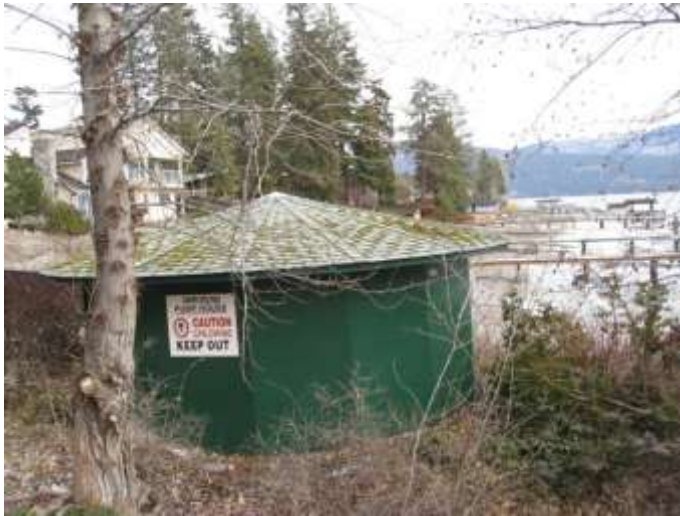
INTAKE AND PUMP STATION

The high lift pumping station and wet well is located right adjacent to the boat launch as shown on the attached drawings under **Appendix A**.

The pumphouse is a wood frame structure and the wet well is of concrete construction. We understand that the roof has been re-shingled since the pumphouse had been originally constructed. In general, this pumphouse structure appears to be in good shape.

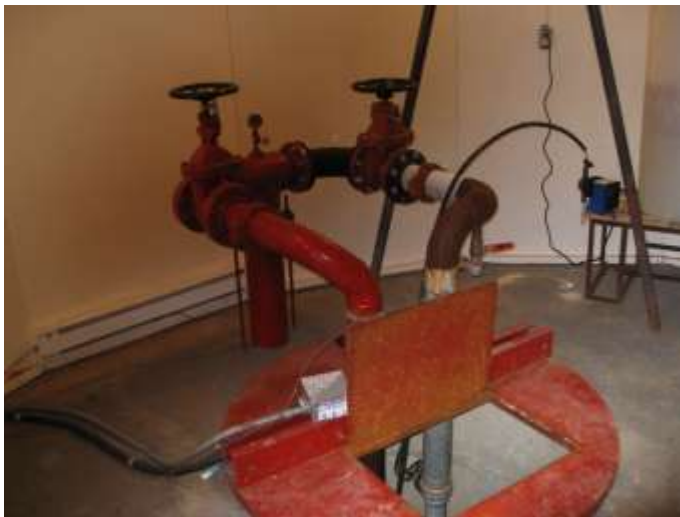
The lake intake consists of a 200mm diameter pipe that runs about 60m out into the lake. The depth of the intake, as confirmed by Aqua-Bility Projects Ltd., is 8.5m below the surface of the lake. The original 1966 drawings show it as CL2400 concrete sewer pipe. Several joints on the intake pipe show signs of leakage. The intake pipe is apparently backfilled with native gravels. Lake levels are said to fluctuate $\pm 0.6\text{m}$ or so, but the fluctuations have not been an issue with the intake elevation. A diver was hired about 15 years ago to inspect and de-silt the intake screen. The recent inspection by Aqua-Bility Projects Ltd. indicates that the intake screen has fallen off and that the screen itself does not meet current M.O.E fishery specification.

1. Complete the maintenance repairs to the intake and wet well as identified within the Aqua-Bility Projects Ltd. investigation and letter.
2. Install a master flow meter on the system at the pumphouse;

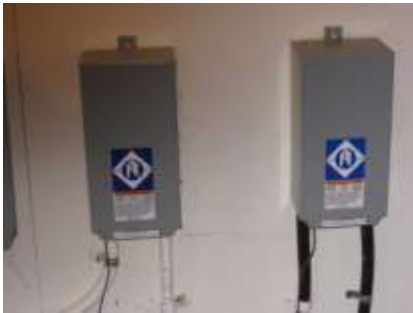
Pump Starters

Both pumps are about 4 years old including the new wall-mounted starters. In addition, the old Goulds submersible pumps (1 – 10 hp and 1 – 3 hp) are in storage in the pumphouse as emergency backups. We understand that the new pumps have never cavitated indicating that the water level in the wet well over the pumps has been of sufficient level under maximum demand.

Under heavy summer water usage, both pumps cannot run simultaneously, as they will trip the 100 Amp breaker in the pumphouse. There is also no pressure gauge on the pumps although distribution pressure is thought to be up around 90 psi typical at the lot line.

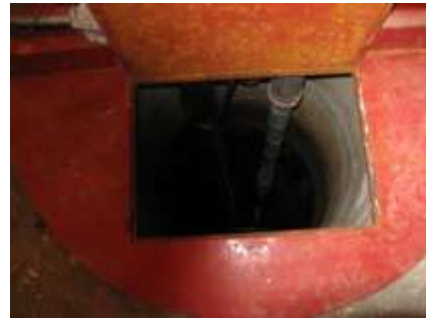
Wet Well

The concrete wet well casing is located inside the pumphouse and is 1200mm in diameter and approximately 4.5m in depth. According to Mr. Muhlberger, he cleans out the wet well annually although there are no maintenance records to indicate this. The wet well pumps consist of the following:

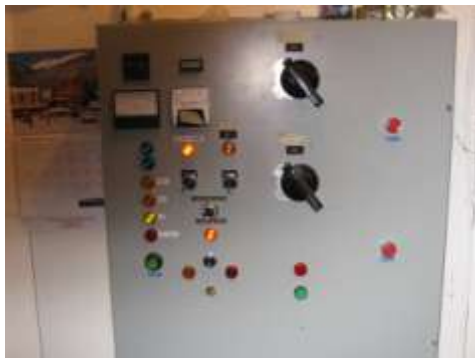
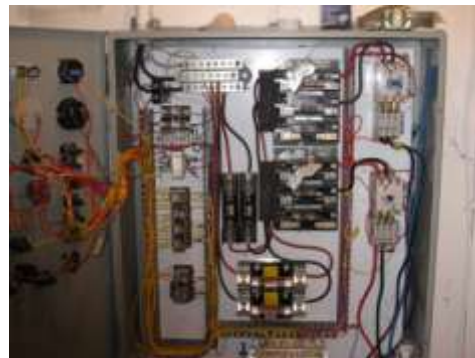
The pictures above show the control panel in the pumphouse. Some of the components in the panel have recently been upgraded including dual starters and other electrical switches, wiring, etc.

The electrical power and control equipment (some new), which is mounted on the wall of the Pumphouse, appear to be in good condition. The only concern might be that a break in the water piping could spray and damage the electrical equipment but screening could be provided to reduce the risk.

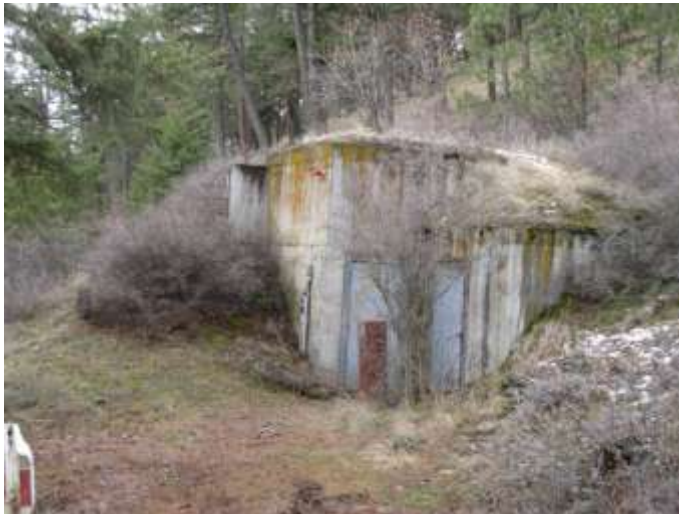
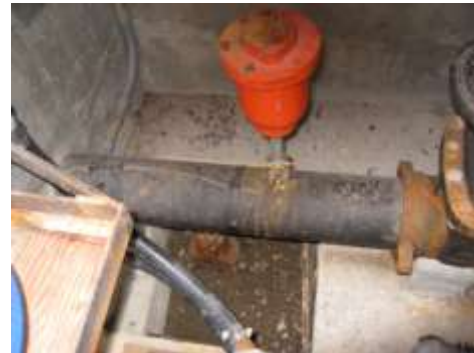
RESERVOIR

The water reservoir for the Fintry Water Utility is located along Fintry Delta Road about half way up the embankment between the lakeshore pumphouse and Westside Road. We understand that the reservoir was built in about 1977. The high water elevation in the reservoir is about 60m above the intake wet well pumps. The 60m head (87 psi) is higher than that shown on the 1966 drawings but, again, these old drawings may not reflect what was actually built and at what elevation.

The reservoir is a partially below-grade, single compartment, unbaffled, reinforced concrete structure (rectangular in shape) with an assumed capacity of 50 m³ (11,000 Imp gallons). The structure has an attached utility room that houses the piping and valves and has an electrical box for a new beacon light on the outside of the structure. The beacon is a warning light that comes on when the reservoir water level drops below minimum and/or there is a power outage.

To meet the RDCO Bylaw standards, the minimum reservoir volume for future water usage and fire storage should be 540 m³. Although the expansion of the existing reservoir is an option, storage would still be inadequate. Another drawback is the age of the structure and thus the condition. The structural integrity of the concrete structure should be verified by a structural engineer if this option is pursued. A more viable option may be the construction of a new reservoir at a cost as estimated in Section 3.2.1.

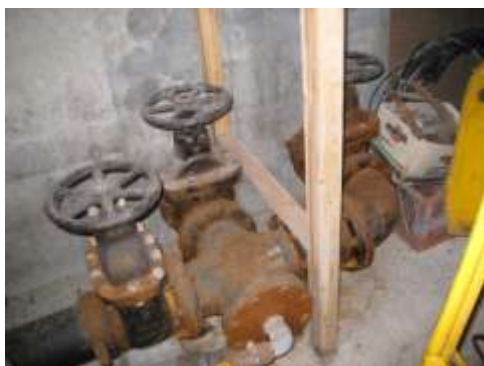
There is a dedicated 150mm ductile iron main from the pumphouse up to the reservoir.

There is a second mechanical/storage room which was built should a second reservoir tank be constructed. Pipe works would be placed inside this room, also adjacent the existing reservoir. New electrical outlets have been installed inside the mechanical room including electric heaters in both the utility and mechanical rooms.

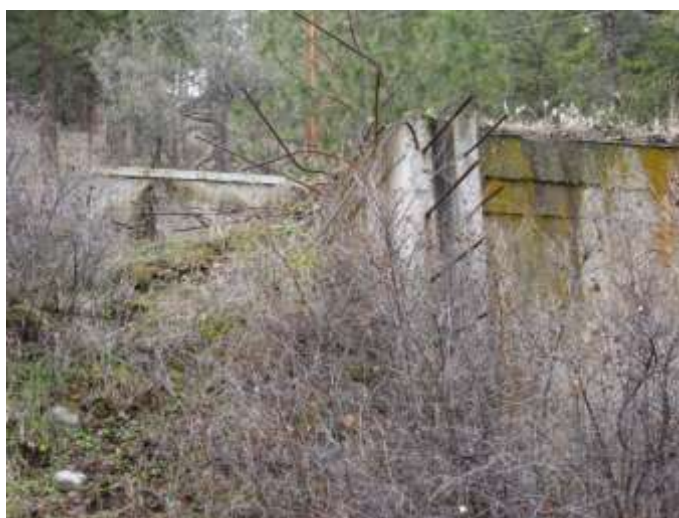
The concrete reservoir was designed and built for future expansion. The original structure was designed such that a second reservoir cell and possibly even a third cell could be added on to the existing structure. The existing reservoir has extension walls in-place with rebar for tying into newly constructed concrete walls. (see photo to the right and the 1966 Drawing #57903 in the Appendix).
